MACKINAC BRIDGE RECEIVES ELECTRICAL UPGRADE

AT A COST ALMOST EQUAL TO ITS ORIGINAL CONSTRUCTION, the Mackinac Bridge received an extensive upgrade to its existing electrical systems, with the bridge's massive size presenting only one of the challenges to the project.

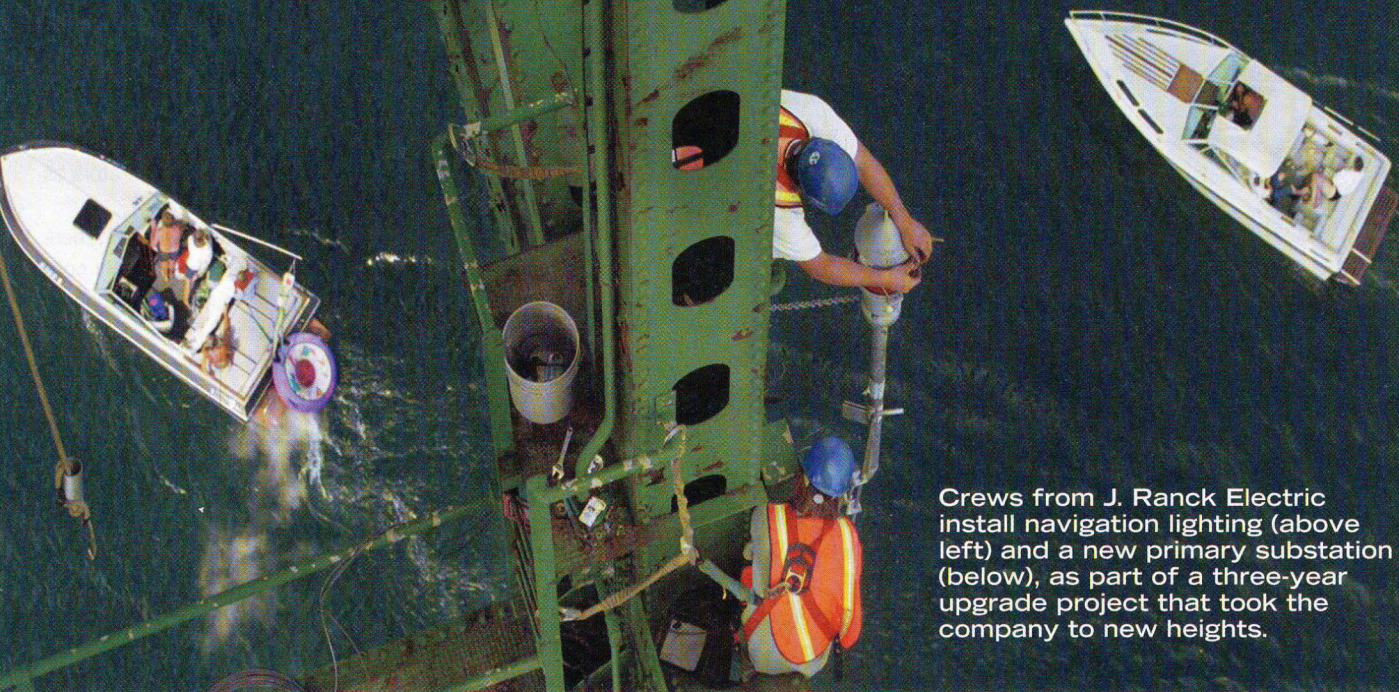
Crews from J. Ranck Electric install navigation lighting (above left) and a new primary substation (below), as part of a three-year upgrade project that took the company to new heights.

"For this project, we replaced all seven substations under the bridge at both ends, which required new 5 kV cable that we had to replace all across the bridge," Faunt said. "We also replaced all the lighting on the bridge, as well as the cable lighting, the lights up on top, and all the cable that fed those lights and the receptacles.

"We installed four 100-foot light towers (480V) at the toll booth on the north end of the bridge, where two were already existing," he added. "On the bridge itself, we installed 183 streetlights that were each 40 feet tall. Then on the towers, we replaced all the aerial, navigation, aircraft warning and floodlights."
